PEQUONNOCK RIVER BASIN
BRIDGEPORT, CONNECTICUT

FOREST LAKE DAM
CT 00078

PHASE I INSPECTION REPORT
NATIONAL DAM INSPECTION PROGRAM

AUGUST 1978

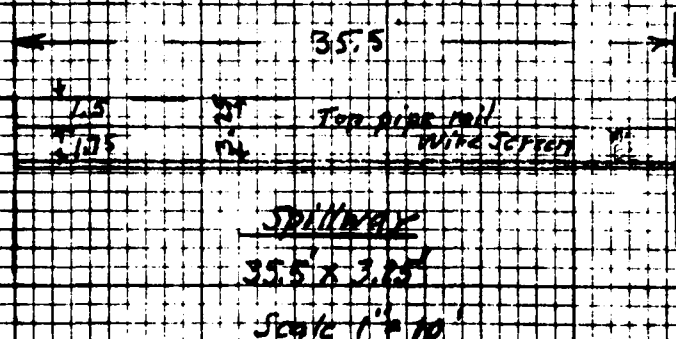
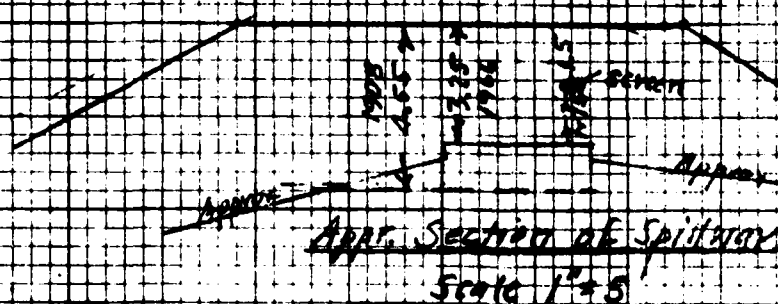
DAM #45
LAKE FOREST
Bridgeport
Watershed 925 Ac
Wind mark 1900'

PRESSENT
Shed = 145 sp. m
H = 3' Max
C = 27
L = 35.5
Q = 500 cfs

$Q = C A H^{3/2}$
 $= 27 \times 35.5 \times 3.2 = 500 \text{ cfs}$

$H = 0.5$
 $C = 27$
 $L = 35.5$
 $Q = 1.4 \times 10^3 \text{ cfs}$
 $= 1400 \text{ cfs}$

NOTE: Evident spillway is inadequate; that screen should be removed, and that other measures should be taken to provide required safety.

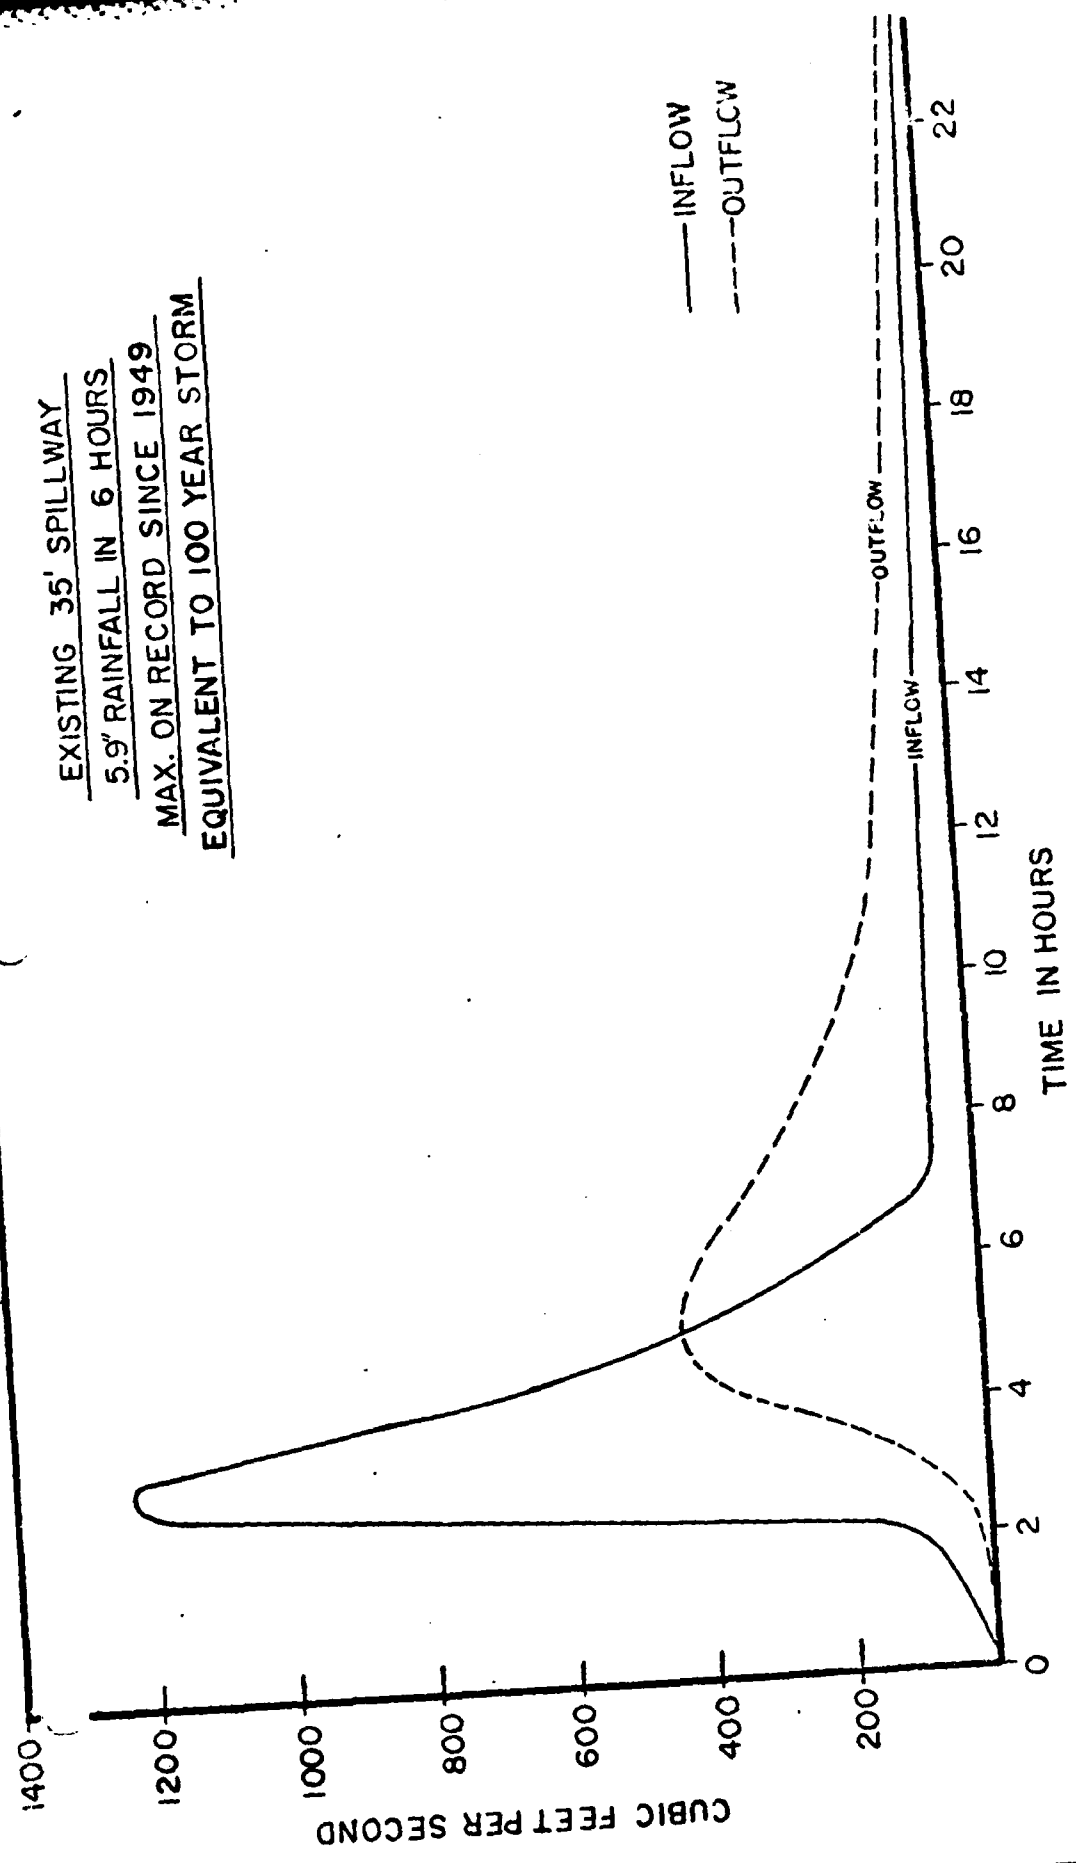
FLOOD ROUTING LAKE FOREST

EXISTING 35' SPILLWAY
 5.9' RAINFALL IN 6 HOURS
 MAX. ON RECORD SINCE 1949
 EQUIVALENT TO 100 YEAR STORM

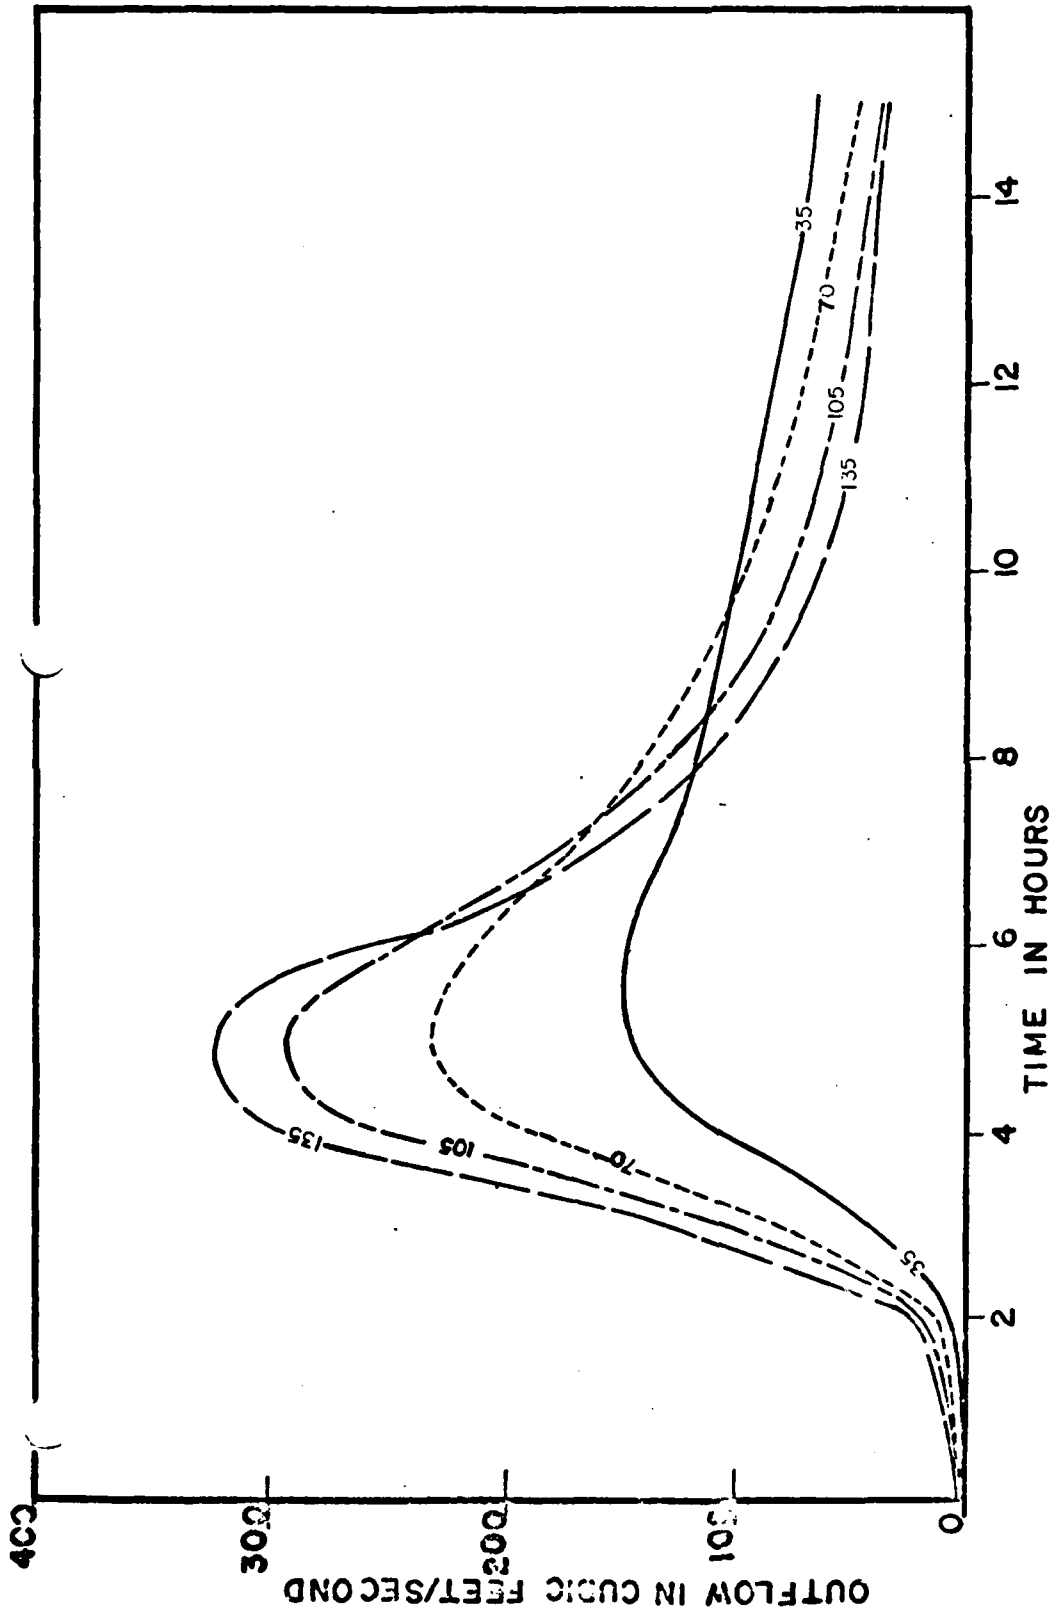
OUTFLOW FOR VARIOUS SPILLWAY WIDTHS

Due to the retention effect of Lake Forest, runoffs to the downstream structures are reduced by 50% to 75%. Plate No. 1 shows the reduction of flows during the period of record, June 22, 1972. Without retention, the outflow would be equal to the inflow. Plate 1 shows a maximum inflow of 1,240 cfs and maximum outflow of 440 cfs or a reduction of 65%.

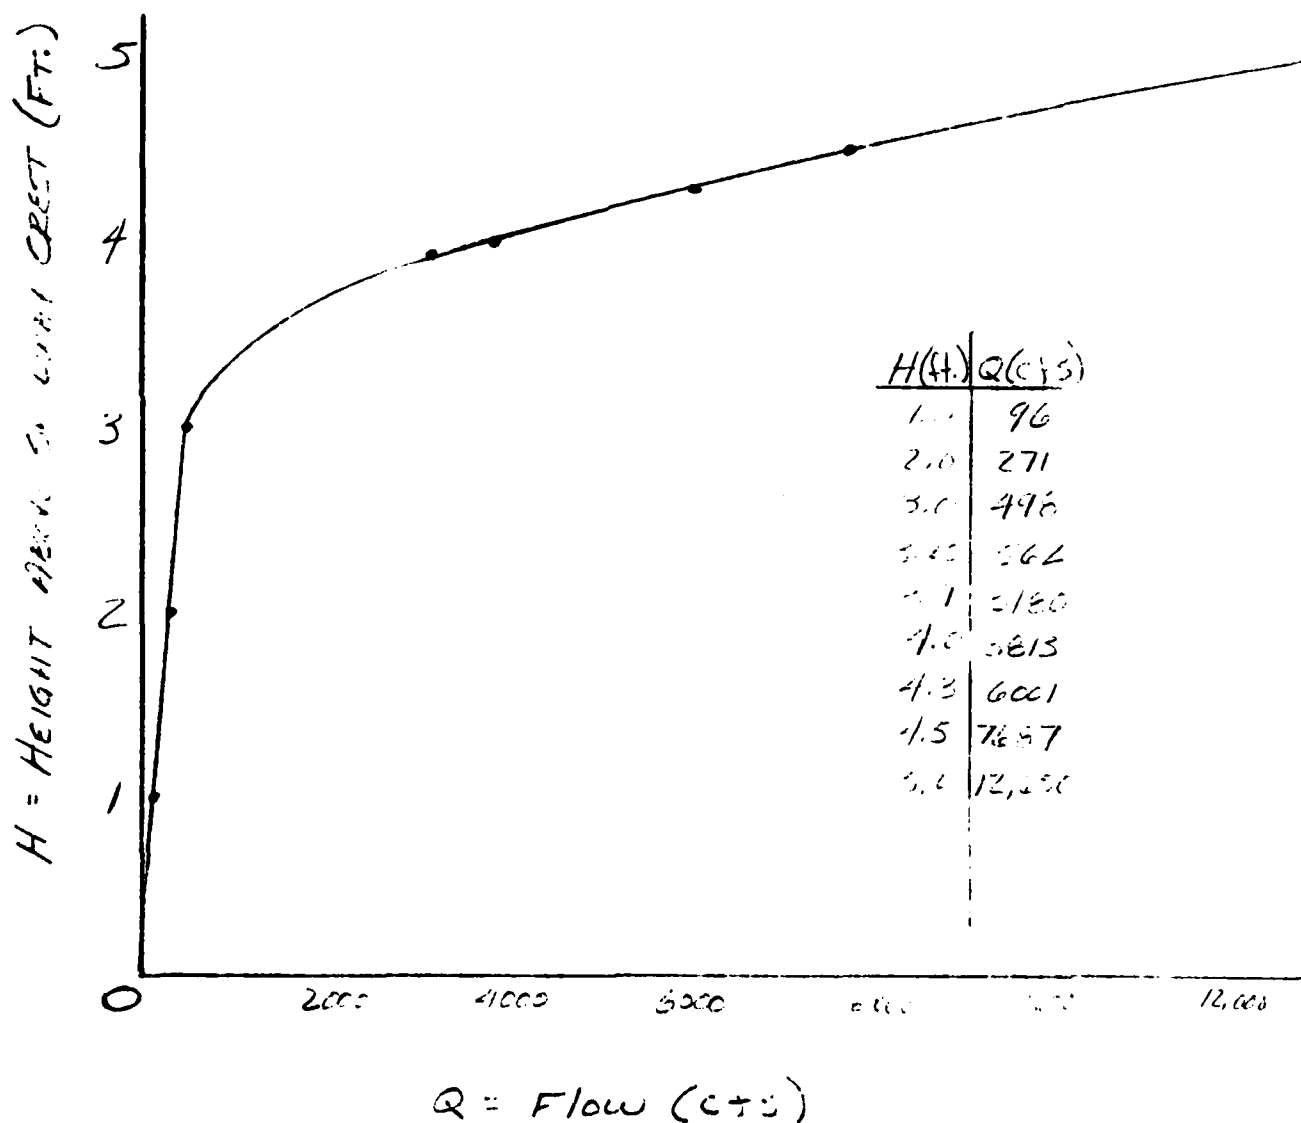
SPILLWAY RATING CURVE

$$Q = 95.9 H^{3/2} + 4455 (H - 3.25)^{3/2} + 312 (H - 3.25)^{5/2}$$
